Manhole Inspection Summary

Manhole # S17G__042MH

Insp Date: **1/24/09 1:33 PM**

Location Address: **114 N WHEELER AVE** Cross Street: **W FAYETTE ST**

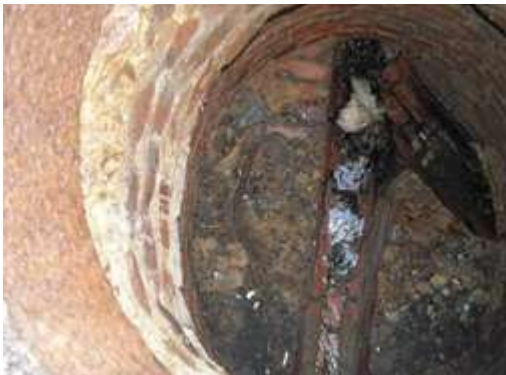
Defect 3

Bench ☒ Exists Material: **Brick** ☐ Parged
Condition: ☐ Sound ☐ Cracked ☐ Root Intrusion ☐ Deteriorated ☐ Leaks ☒ **Debris**

Channel Material: **Brick** ☐ Parged
Channel Exposure: **Fully Open** Junc Dist: **0** nearest .5 ft. Azimuth:
Condition: ☐ Sound ☒ **Cracked** ☐ Root Intrusion ☐ Deteriorated ☐ Leaks ☐ Debris

DEBRIS ON BENCH AND CRACKED CHANNEL

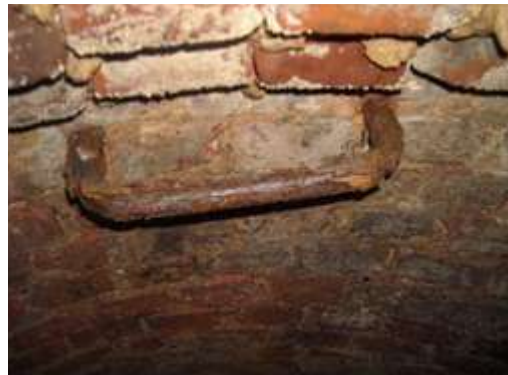
Defect 2

Corbel Material: **Brick and Concrete** ☒ Parged Type: **Concentric/Eccentric**
Condition: ☐ Sound ☒ **Cracked** ☐ Root Intrusion ☐ Loose Brick ☒ **Deteriorated**
Infiltration: ☒ None ☐ Joint ☐ Cracks ☐ Mortar ☐ Roots ☐ Wall

CORRODED STEP AND DETERIORATED CORBEL

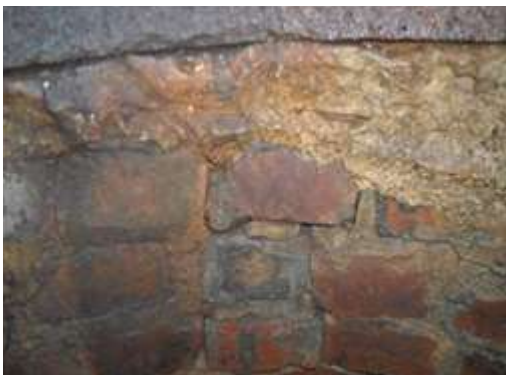
Defect 1

Chimney / Frame Adjustment ☒ Exists Material: **Brick and Concrete** ☒ Parged Height: **2** (in.)
Condition: ☐ Sound ☒ **Cracked** ☐ Root Intrusion ☐ Loose Brick ☒ **Deteriorated**
Infiltration: ☒ None ☐ Joint ☐ Cracks ☐ Mortar ☐ Roots ☐ Wall

LOOSE AND DETERIORATED BRICK IN CHIMNEY

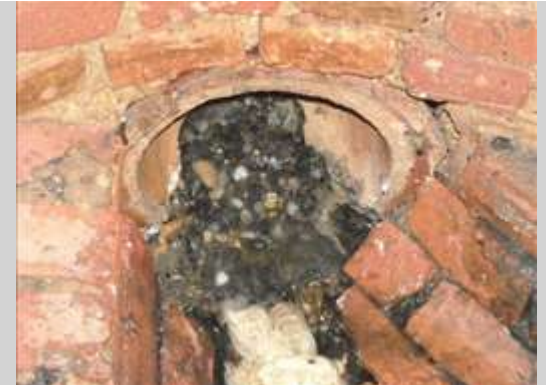
12 O'Clock Outflow

PIPE SEAL IS CRACKED, BOTTOM OF
PIPE IS BROKEN OFF

Infiltration: **None** Pipe Seal Cond: **Broken**

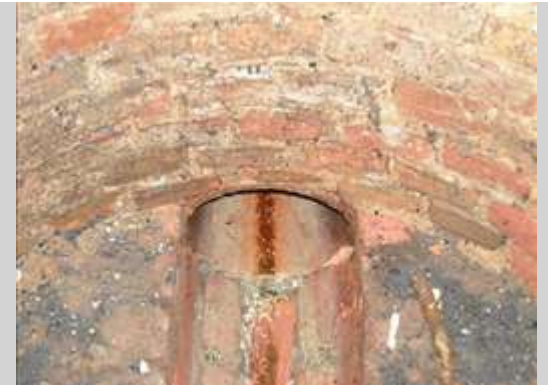
6 O'Clock Inflow

PIPE SEAL IS CRACKED, BOTTOM OF
PIPE IS BROKEN OFF
